asphalt contractor

September 1997 **PAVING AMERICA**

**Patching the
pothole problems**

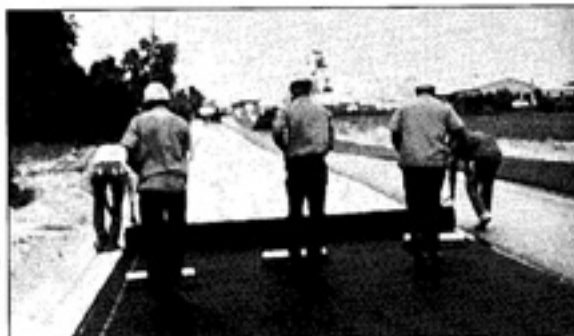
After wrinkles are cut, all overlapped wrinkles and all overlaps in the fabric should have an additional tack coat applied.

The overlapped wrinkles and all overlaps in the fab-

ric should have an additional tack coat applied and be sufficient enough to saturate the two layers of fabric and make a bond. If this is not done a slip plane will exist at each overlapped joint, resulting in a crack and potential stripping of the asphalt from the fabric. Overlaps should be no more than 6 inches (150 mm) on longitudinal joints, and one foot at transverse joints.
