asphalt contractor

September 1997 **PAVING AMERICA**

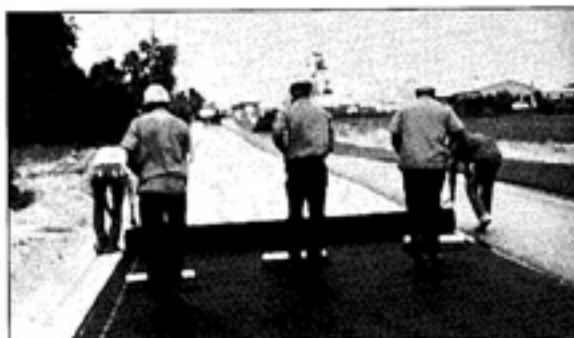
After wrinkles are cut, all overlapped wrinkles and all overlaps in the fabric should have an additional tack coat applied.

The overlapped wrinkles and all overlaps in the fab-

ric should have an additional tack coat applied and be sufficient enough to saturate the two layers of fabric and make a bond. If this is not done a slip plane will exist at each overlapped joint, resulting in a crack and potential stripping of the asphalt from the fabric. Overlaps should be no more than 6 inches (150 mm) on longitudinal joints, and one foot at transverse joints.
